CONCRETE PERFORMANCE IN GRAND COULEE FOREBAY DAM, WASHINGTON: 10-YEAR CORE REPORT

November 1985
Engineering and Research Center

U.S. Department of the Interior
Bureau of Reclamation
Division of Research and
Laboratory Services
Concrete and Structural Branch

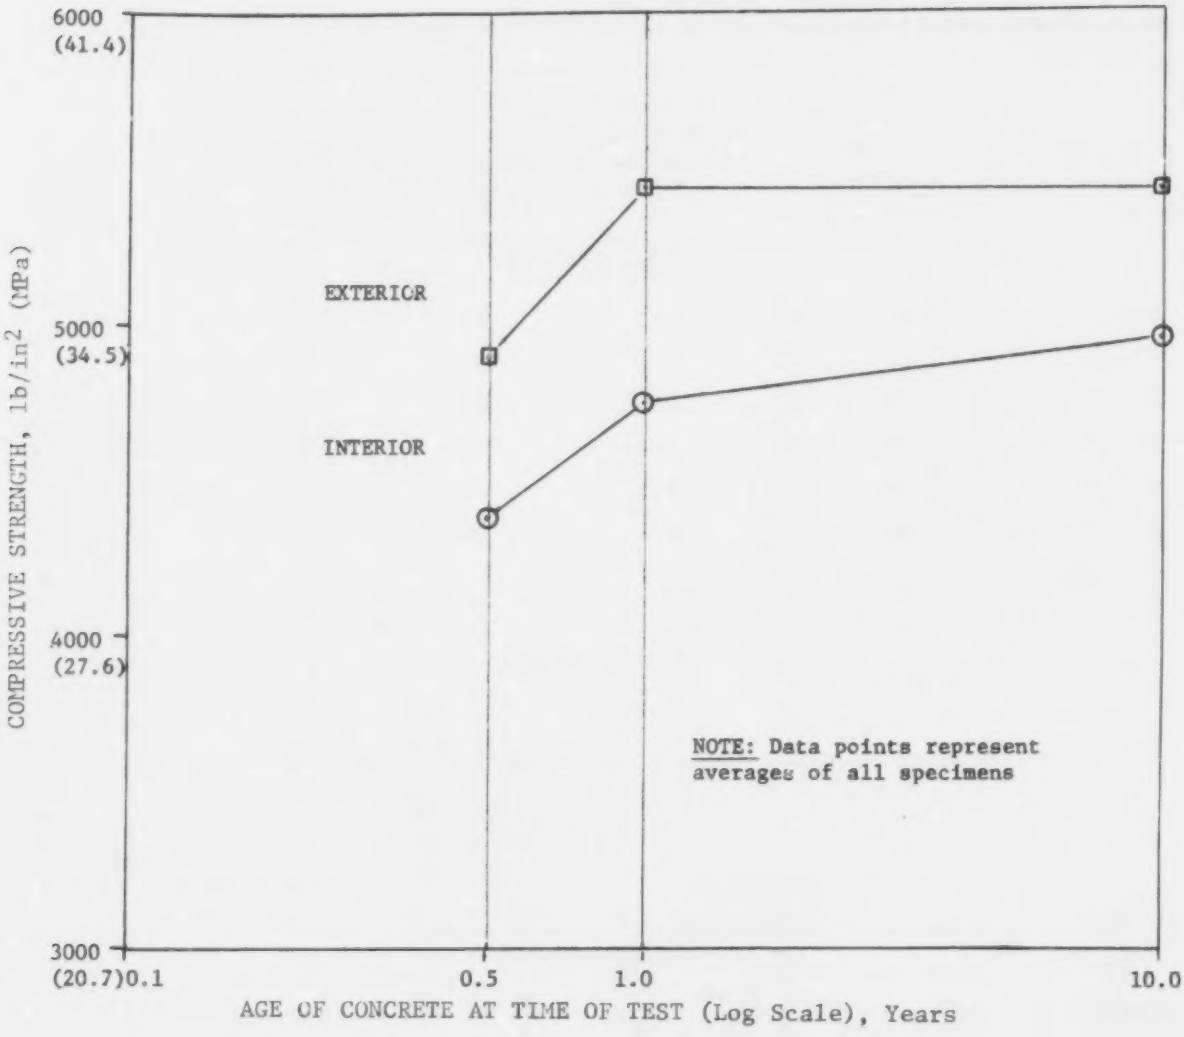
Figure 1. – Compressive strength development – Grand Coulee Forebay Dam.

for this fact, but the results do indicate that there has been no strength gain in the exterior concrete after 1 year. This may be reasonable because the exterior concrete had higher early strengths and may have been subject to moisture and temperature variations that slowed or stopped hydration. As expected, the coefficient of variation for these cores was less than that for either the 6-month or 1-year test results. The most obvious reason for strength differences or variations is the size and distribution of coarse aggregate in the various cores. Some of the cores, such as WDB-1-3, contained only 38-mm (1½-in) maximum size aggregate; which resulted in higher strength. The lowest strength exterior core, 32.5 MPa (4710 lb/in²), contained plus 76-mm (3-in) aggregate, several pieces of which were on the outside of the core where they induced stress concentrations.

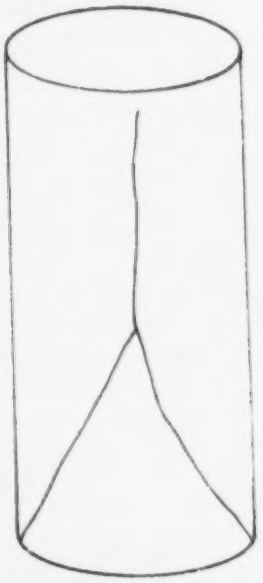
Explosive break. Broke across large 6 in. aggregate particle (see photograph). Trapped air voids up to 3/8" in. visible in sockets of large aggregate particles. Cement matrix appears normal. No visible reaction products. Bond failure typical around larger coarse aggregate particles, however, many of the smaller coarse aggregate particles broke through. Percent of fractured particles estimated to be between 5-10%. Aggregate particles greater than 3 in. represent about 30% of total area of fracture surface.
Coarse aggregate typically well rounded with smooth surfaces.

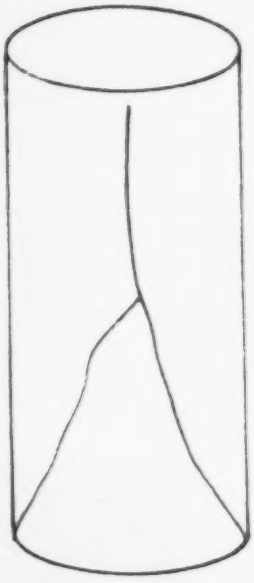
Explosive break. Relatively good bonding characteristics - abundance of particles broken through (estimate 40%). Few aggregate pieces larger than 1 inch. Cement matrix appears normal - no visible reaction products. No pieces larger than 3 in. Coarse aggregate typically well rounded with smooth surfaces.

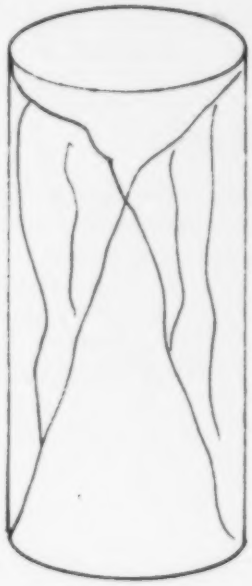
Explosive break. Well rounded coarse aggregate 1½ in. maximum size. Break occured mostly around particles. Only about 5% broke through. No coarse aggregate particles over 3 in. in size. Cement matrix normal, no excessive trapped air voids or reaction products noted.

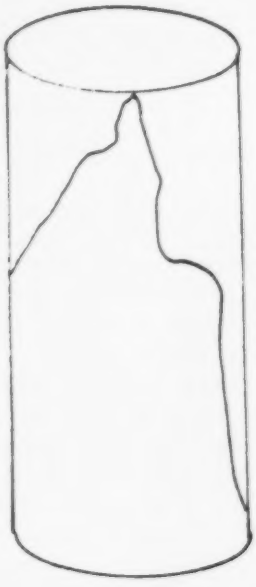
Explosive break. Coarse aggregate well rounded with smooth surfaces. Maximum size up to 3 in. Cement matrix normal, no excessive air in sockets, no visible reaction products or deterioration. About 10% of coarse aggregate pieces broke through. Only about 5% are 3 inches in size or larger.

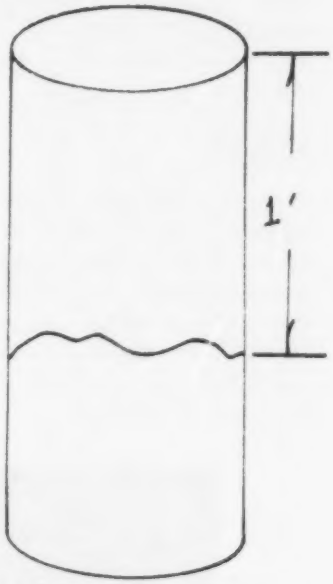
TENSION BREAK.

This core contains several large coarse aggregate particles which dictated break as shown in the photograph below. Note trapped air voids in sockets (right piece in photograph is botton segment). Cement matrix looks normal. Less than 1% of aggregate broke through. Pieces over 3 in. in size make up about 40% of exposed surface. Coarse aggregate typically rounded with smooth surfaces.

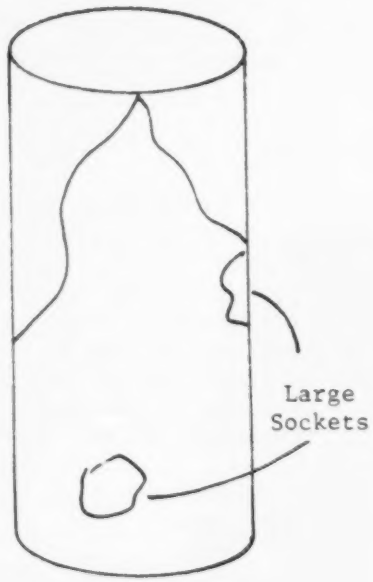
Explosive break. Only about 2% of coarse aggregate particles broke through. About 15% of pieces are 3 in. or greater in size. Two large sockets remained in the intact core after testing. These did not have excessive trapped air voids. Cement matrix appears normal. No reaction products or signs of deterioration noted. Coarse aggregate pieces generally well rounded with smooth surfaces.

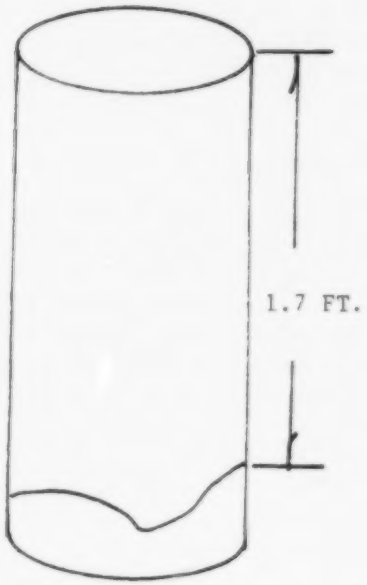
PROJECT: Grand Coulee Forebay Dam
BORING NO. 145/464 BLOCK: 109
TYPE CONCRETE: Interior
TENSILE STRENGTH (PSI) 45
SAD LABORATORY No. 145/464
DEPTH (Ft.) 6.2-7.9 CORE No. 3

This core broke in tension close to the bottom where 1½ to plus 3 in. aggregate pieces were numerous. Numerous sockets left by the rounded coarse aggregate particles appear in the photograph below. Note moderate amount of trapped air voids and numerous rounded pieces. Only one aggregate particles broke. The cement matrix appears normal, no reaction products were noted. The voids were clean. About 50% of fracture surface appears to be 3 in. or larger.

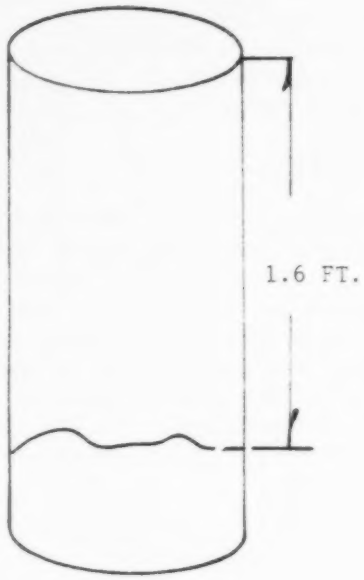
Core pulled apart about 0.4 ft. from bottom. Only a small percent (∿2) of the coarse aggregate pieces broke apart in the test. About 20% of the coarse aggregate appears to be 3 in. or larger (see photograph). Core piece on right in photograph is the bottom portion. Note small amount of trapped air voids in sockets (this would be the bottom of the coarse aggregate pieces). Since more matrix and a greater quantity of smaller particles are present, the tensile strength is higher than most of the cores tested in tension.

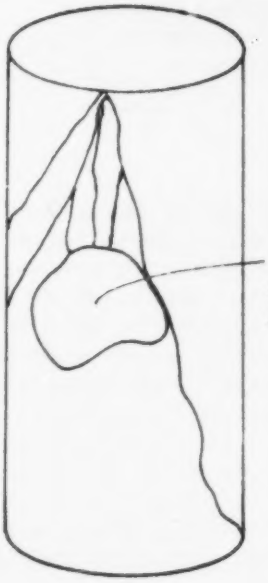
Explosive break. Bond failure around larger coarse aggregate particles common (see photograph). On fracture surface these represent about 15% of the surface area. Trapped air voids common but not excessive. When present they are clean. Cement matrix looks normal - no reaction or alteration products noted. Percent of fractured coarse aggregate particles small (about 2%).

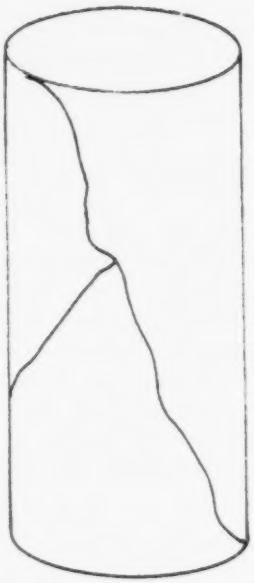
Explosive break. About 10% of coarse aggregate pieces broke across (sheared) during test. There were no pieces 3 in. or larger in size. Coarse aggregate well rounded with smooth surfaces. Cement matrix looks normal. No reaction or alteration products noted. Voids are clean.

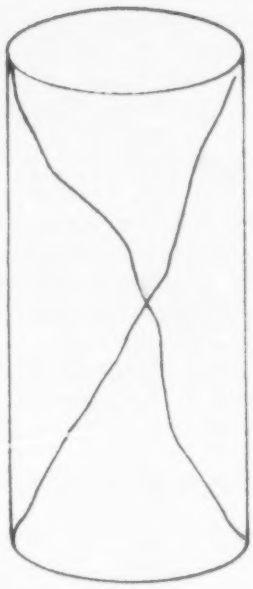
Explosive break. Very small percent (5%) of broken coarse aggregate particles. Aggregate 3 in. or larger represents about 10% of fracture surfaces. Cement matrix appears normal - no visible reaction or deterioration products. No excessive voids but when present they are clean. Coarse aggregate is typically well rounded with smooth surface.

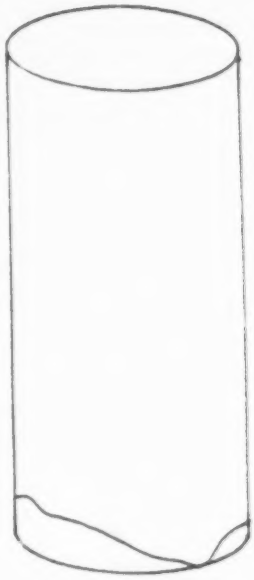
PROJECT: Grand Coulee Forebay Dam
BORING NO. 113-1 BLOCK 113
TYPE CONCRETE: Interior
TENSILE STRENGTH (PSI) 80
SAD LABORATORY NO. 145/472
DEPTH (Ft.) 9.2 - 10.9 CORE NO. 3

1.1 MPa (170 lb/in²) tensile strength. This average includes core No. 113-1-3, which broke at 0.55 MPa (80 lb/in²), probably because of a piece of weathered aggregate and a large piece of aggregate in the failure section (See photograph in app. D).

Core contains an abundance of large (> 3 in.) coarse aggregate particles. Core broke in tension at bottom about 1-2 in. from steel plate. The photograph shows areas of epoxy failure and abundance of large aggregate. Large aggregate particles cover about 40% of fracture surface. Note yellow brown weathered particle and smooth sockets in photograph.

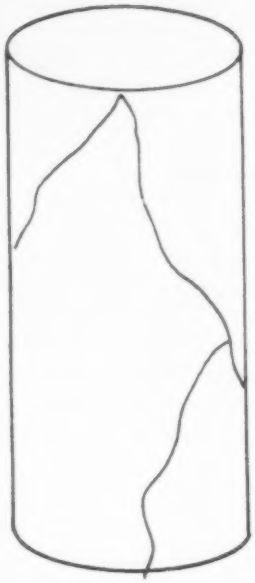
Explosive break. Well consolidated, sound concrete. Cement matrix appear normal. No evidence of reaction products or concrete deterioration. About 5% of coarse aggregate is 3 in. or larger. About 10% of the exposed aggregate are fractured or sheared. Few angular coarse aggregate particles but most are well rounded with smooth surfaces.

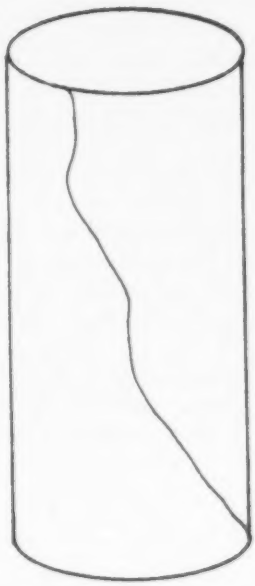
Explosive break. Sound well consolidated concrete. No evidence of concrete deterioration or reaction products. Cement matrix appears normal. Aggregate well rounded with smooth surfaces. Pieces 3 in. or larger represent about 20% of exposed fracture furface. About 5% of aggregate (all sizes) particles sheared.

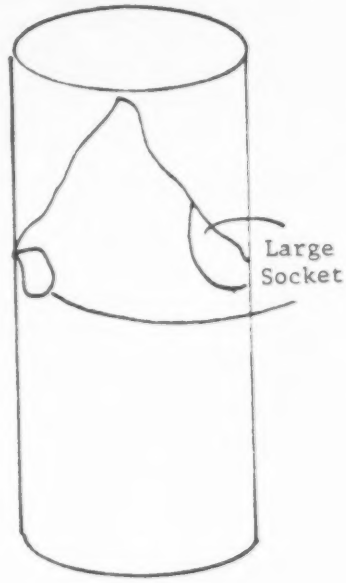
Explosive break. Numerous large sockets on intact core. Aggregate pieces 3 in. or larger make up about 25% of fracture surfaces. These are typically well rounded in shape. Only about 2% of the aggregate broke (sheared) during the test. The cement matrix appears normal. No gel or deterioration noted. Note smooth sockets on core outer surfaces.

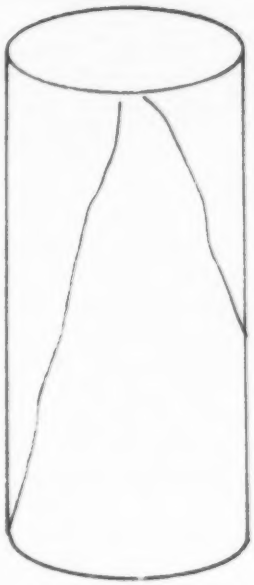
Explosive break. General trend to break around larger coarse aggregate particles. Sockets have a moderate amount of trapped air voids. Note large sockets in photograph. Estimate about 15% of aggregate is 3 in. or larger. Cement matrix appears normal. No gel exduations or concrete deterioration noted. Sheared broken aggregate is about 10% of aggregate pcs.

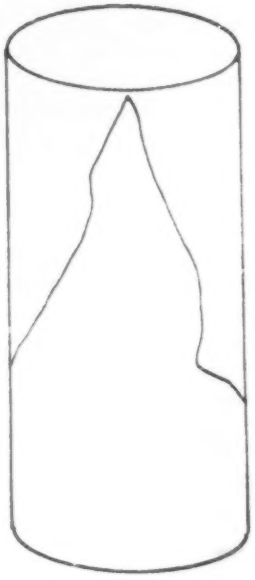
Explosive break. Core contains an abundance of 1½ in. to 3 in. coarse aggregate particles. These are usually well rounded with smooth surfaces. About 15% of the aggregate exceed 3 in. in size on fracture surfaces. Sheared, fractured pieces are about 10%. Cement matrix normal - no signs of deterioration or chemical reactions (e.g.,siliceous gel, etc.)

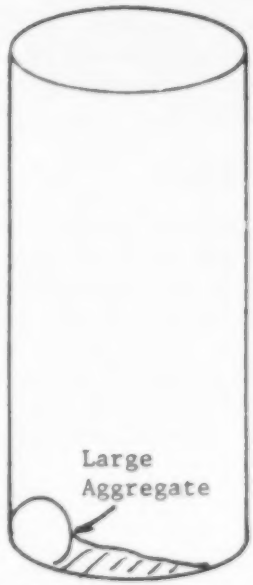
Epoxy - concrete bond failure occured near bottom of core where attached to steel plate. Reddish brown area is the epoxy on steel plate (see photograph below). One large coarse aggregate piece on fracture surface covers about 10% of area. Only about 2% of the aggregate broke across. Sockets contain a few trapped air voids. Cement matrix appear normal. No exudations or signs of deterioration.

Shaded area remained glued to bottom plate.

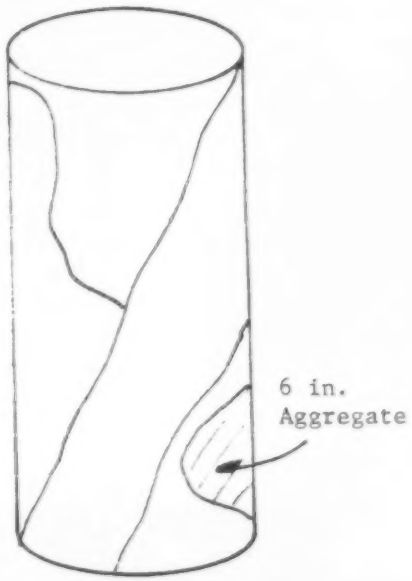
Explosive break. Some large (about 20%) coarse aggregate pieces are present. Break occured around most of these but also through one 4 in piece. Sheared broken pieces represent about 15% of total aggregate exposed. Some sockets contain moderate amounts of trapped air voids. All are clean, that is, they have the color of normal cement. No signs of concrete deterioration.

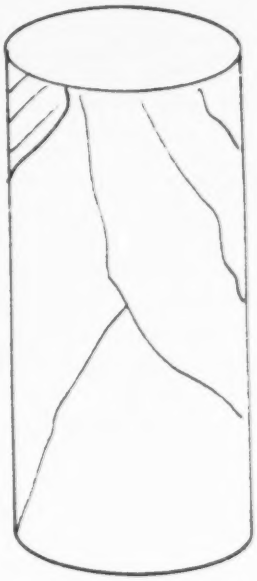
Explosive break. Large coarse aggregate at top appears to have dictated fracture pattern. 15-20% of exposed aggregate is 3 in. or more in size. It is estimated that 30% of the aggregate sheared or broke across particle. Aggregates well rounded with smooth surfaces. Cement matrix appears normal - no excessive trapped air or signs of deterioration.

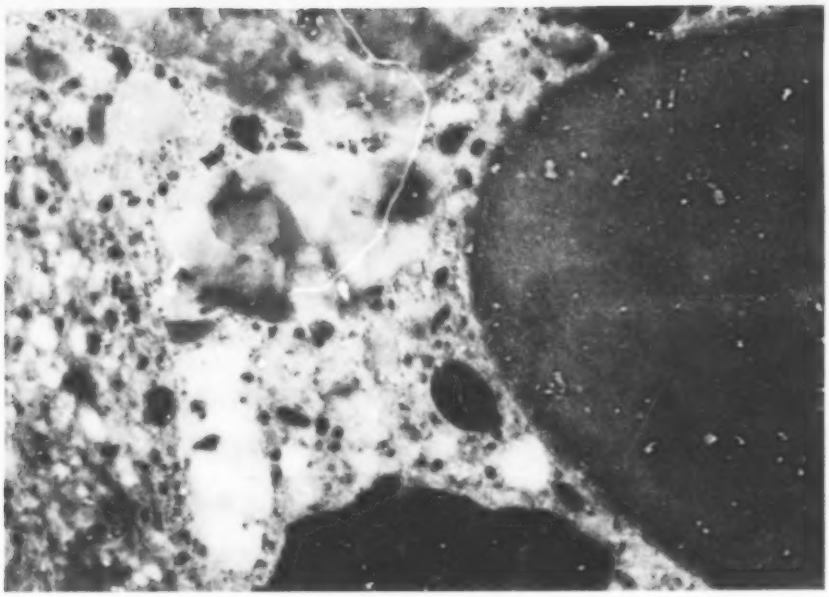
Figure 1. Polished surface (approx. 6.5x). Concrete core from Hole 109-1, Block 109. The rim on the particle to the right is the result of oxidation of the iron bearing carbonate mineral (probably ankerite) scattered throughout this rock particle.
